Eastern Yar Catchment

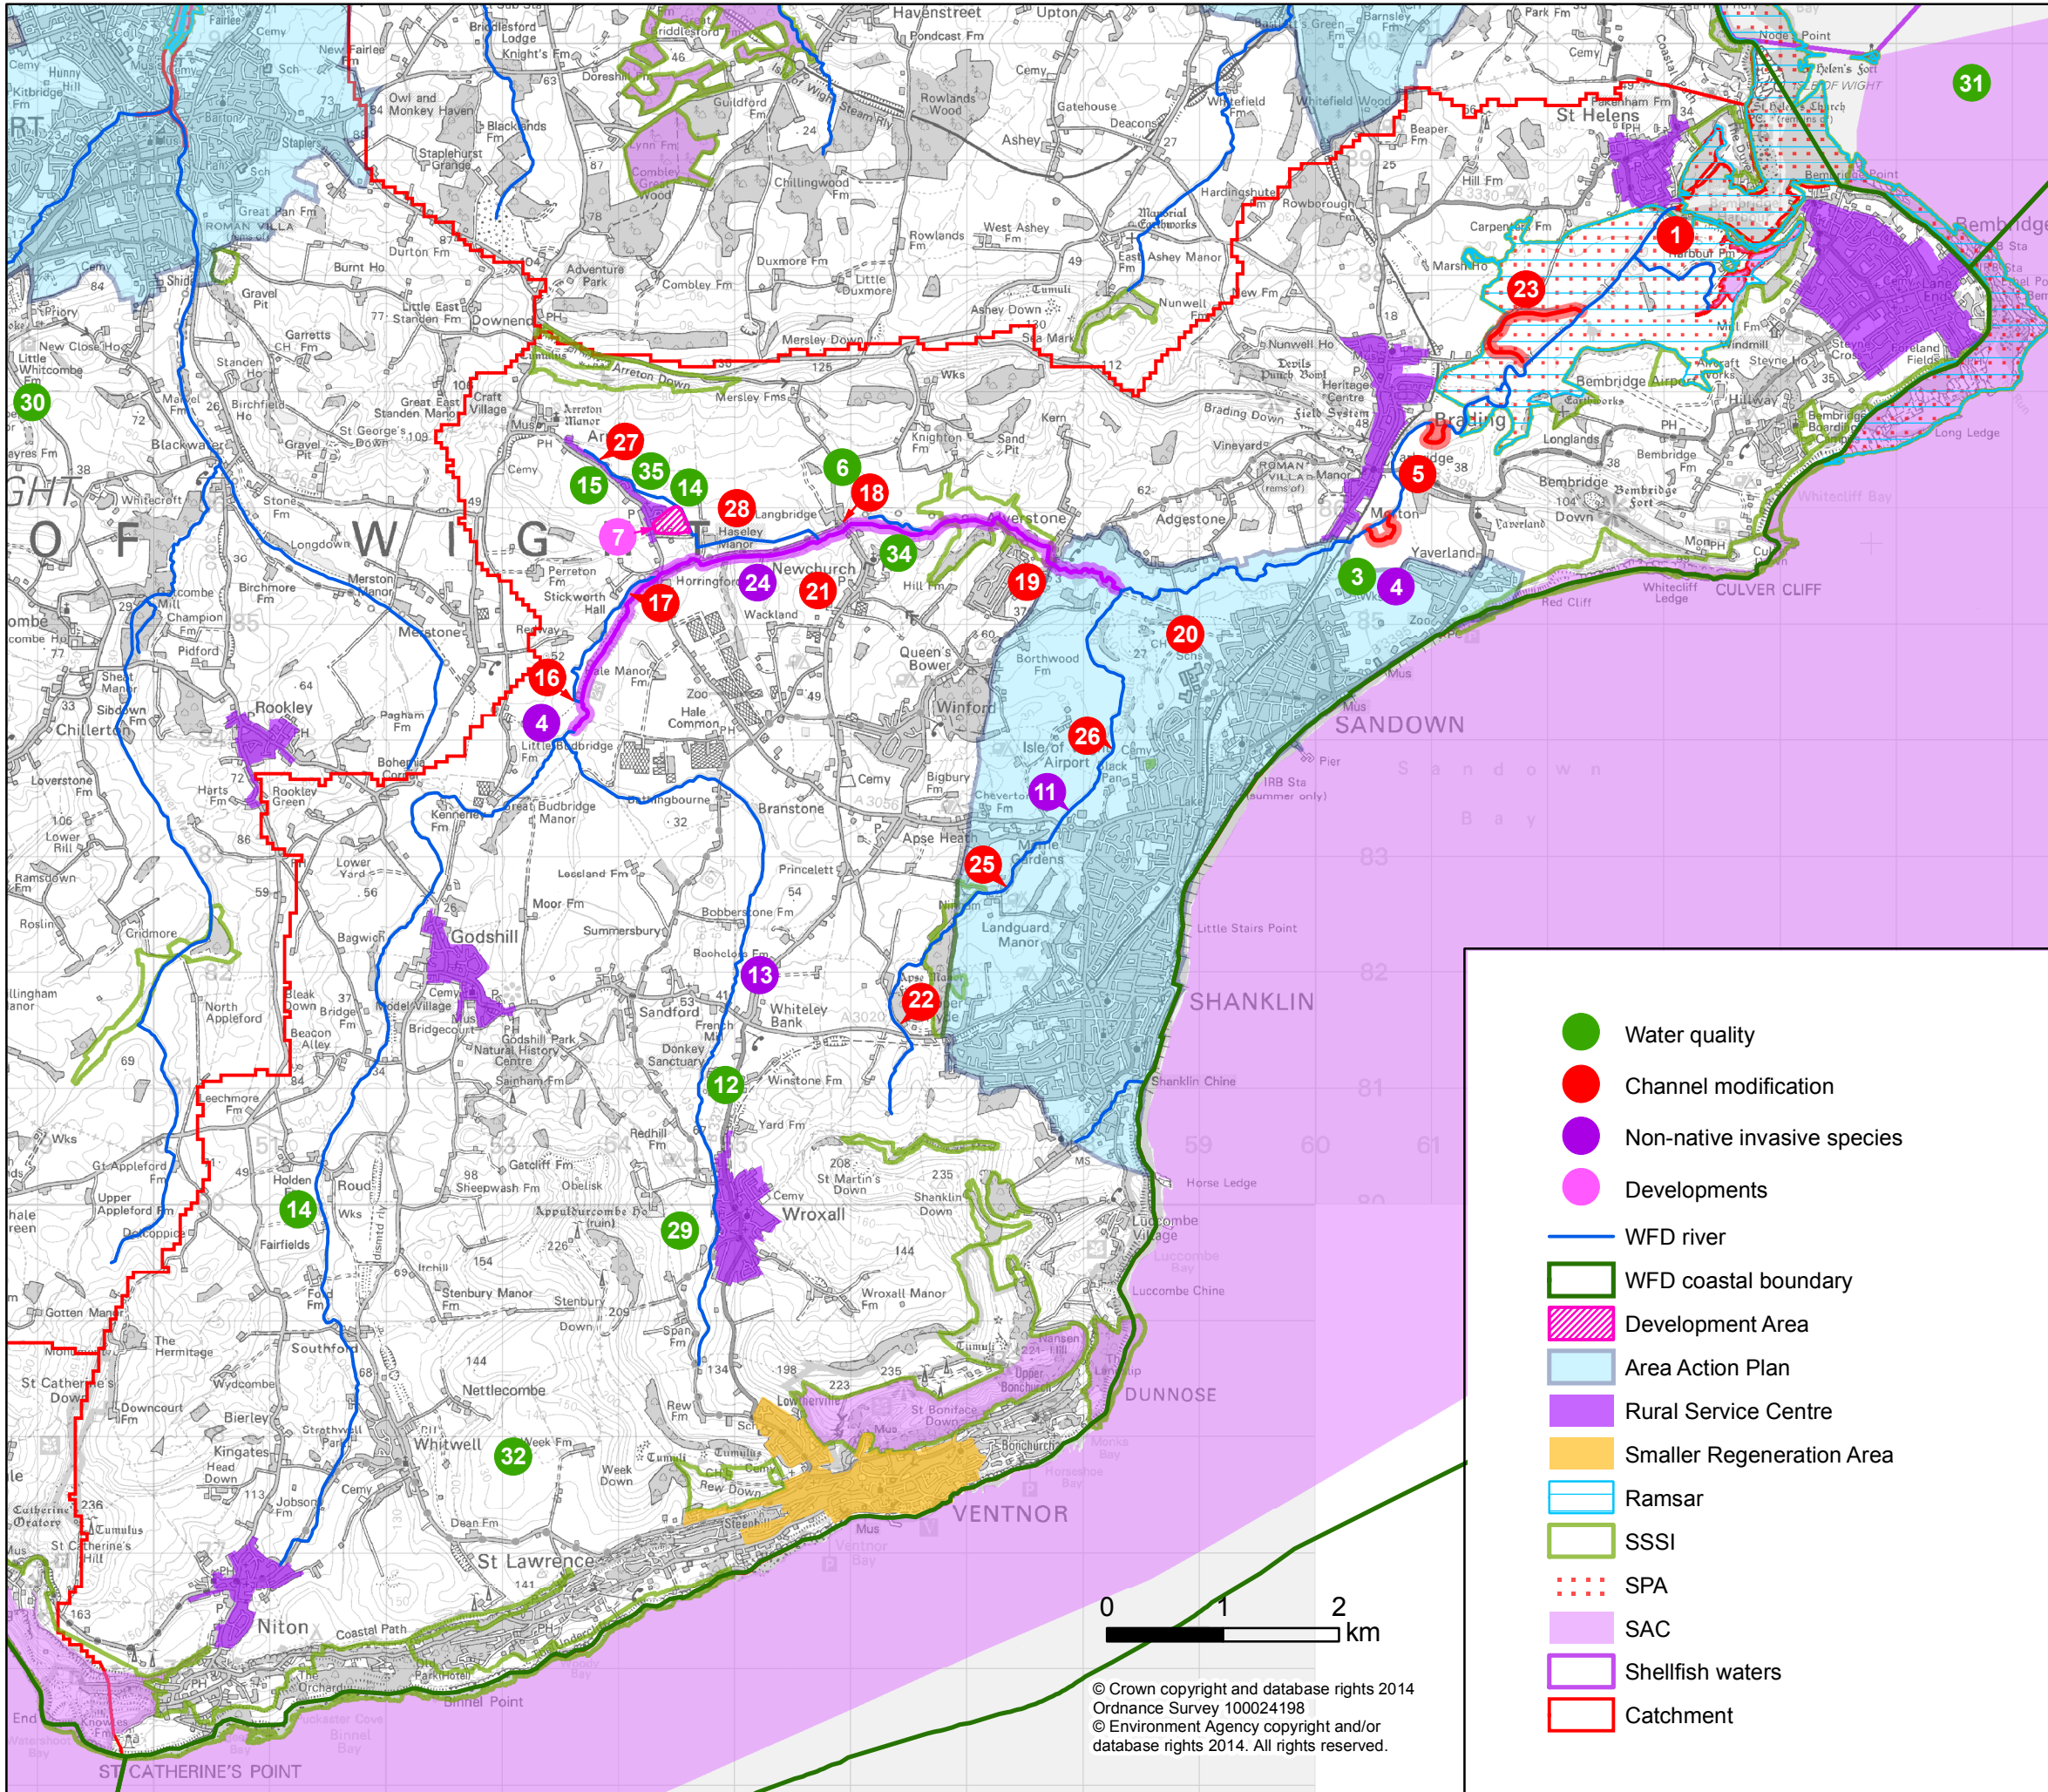
- 1 Slow flow because Bembridge Tidal Gate prevents tide and salt water access.
- 3 College Close Industrial Park in Sandown affects water quality. Spills at College Close WPS.

- 4 Non-native invasive species (NZ stonecrop) on council land.
- 5 Yarbridge short span restricted flow and holds water upstream. Monitoring for fish at Yarbridge - poor results. Fish are under pressure from sediment, poor morphology, flow and obstructions.

- 6 Phosphate overall on E Yar (09-15) is low, but interim fail. Invertebrates overall (09-15) are poor but have improved. Further investigations planned.

- 7 Development proposed for 48 or 98 homes. Appeal made against initial rejection of 98.
- 11 Himalayan Balsam downstream of A3056
- 12 Wroxall WWTW. Southern Water is considering work to improve water quality (not in next business plan).

- 13 Non-native invasive species control in particular Himalayan Balsam and Japanese Knotweed.
- 14 Upper Yar: Aquatic plants affected by phosphate, further investigations due, near Roud WwTW. Site due for treatment improvement in next SW business plan.

- 15 Arreton Stream: Phosphate good, interim fail. Invertebrates poor but improving. Likely source is diffuse pollution, septic tanks, Hazely Combe and Arreton STWs. Southern Water is considering work to improve water quality as not in SW's next business plan. Iron rich impact of the geology also affects inverts.

- 16 Probably blocked culvert, silted off-take channel, banks overgrown
- 17 Low concrete weir up and downstream of Horringford Bridge. Channel bed and banks are concrete. No elver or fish passage facility.

- 18 Concrete section and weir downstream of Langbridge Road Bridge. No fish or elver passage facility.
- 19 Alverstone Mill has 2 weirs, sluices and concrete channel. Lower weir has v-notch but no other fish pass facilities.

- 20 Concrete channel section and drop boards upstream of Longwood Bridge on Golf Links Rd
- 21 Straightened and deepened channel between Horringford and Langbridge.

- 22 Scotchells Brook: old stone weir blocks fish. Immediately downstream, a 300mm wide culvert under road is blocked with debris.
- 23 Opportunity to reinstate meanders.

- 24 Himalayan Balsam pulling on Eastern Yar from just after the confluence of the Wroxall Stream (through Horringford, Langbridge and Alverstone, to just before confluence on Scotchells Brook). Parrots feather, Crassula and Japanese Knotweed.

- 25 Weir at the outlet of an on-line artificial pond.
- 26 Inaccessible sluice
- 27 Arreton Stream is very narrow, intermittently culverted and constrained by a revetment beneath dense vegetation.

- 28 Arreton is heavily overgrown and runs under bridges through culverts. Phosphates evident from diffuse run-off from intensive agriculture. Sediment also high.

- 29 Central Downs chalk poor status: rising trends at Carisbrooke due to historic nitrates and farming on chalk.
- 30 Dissolved inorganic nutrients (DIN) from sewage, fertilizer etc causes 'eutrophication' - excessive seaweed and algae growth, which upsets the aquatic ecosystem. This causes a failure under the Nitrates Directive (categorised as Polluted Waters (Eutrophic)), and the Urban Waste Water Treatment Directive (Sensitive Areas (Eutrophic)).

- 31 Southern Downs chalk: poor quality - pesticide detections near Niton are rising. Ventnor Safeguard Protection Zone failing - need to find reason for failure (may be related to method of water collection). St Lawrence Spring has rising nitrate trend over last 6 years after years of level results. Pollution prevention visits to industrial estates, petrol stations, business users given advice on storage of oils, chemicals and potentially hazardous substances. Advice to farmers on chalk and other aquifers.

- 32 Ferrous discharge from outlet tower. Likely source is the nearby mining pit. SZ5668485989
- 35 Fine sediment entering watercourse from farmyard along deep gullies from tractor tyres SZ5430386099 /SZ5429286100
